1215/09

SAFETY NOTICE PVE623C FILLER VALVE

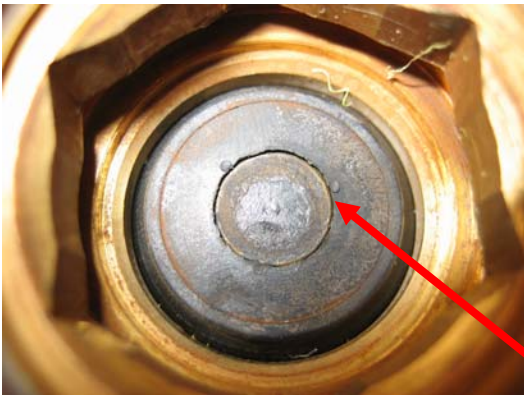
Sherwood has become aware of some failures in the PVE623C filler valve installed into refurbished ASME propane tanks. All reported failures have occurred with valves that have either a 3008 or 4308 date code. The failure occurs when the rubber seal is separating from the brass poppet at the time of first fill. The separation may cause leakage of propane gas when the fill hose is disconnected from the valve. See photos below for example of separation. In some cases a gap can be seen between the top of the poppet and the rubber seal (left picture). In other cases, complete separation has occurred where the rubber seal has completely come off the brass poppet (right picture).

Rubber Seal Separating from Brass

If the valve is not leaking when the fill hose is disconnected then the valve is functioning correctly. If there is leakage or apparent separation then immediately connect a Sherwood PA901B adapter to the filler valve. The adapter utilizes a secondary check mechanism and can be left in service.

Sherwood will provide a PA901B adapter to customers who have PVE623C filler valves with the date codes mentioned above that are currently installed into refurbished tanks. Please contact customer service at 1-888-508-2583 for availability.

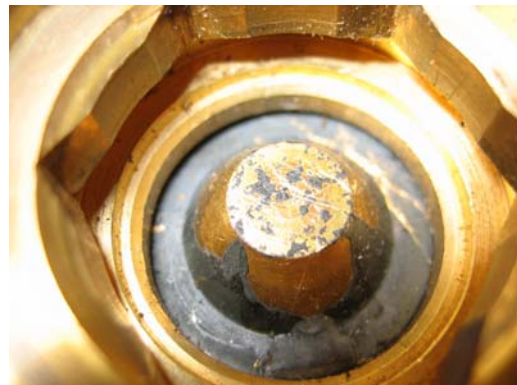
Rubber Seal Missing

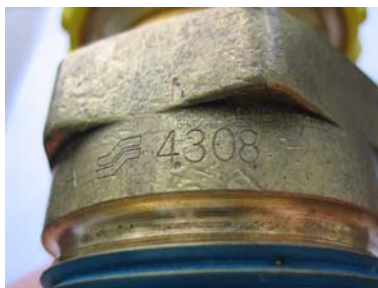
The valve identification stamping and date code are located on the outside of the valve on the diameter above the pipe thread and below the wrench installation hex. See photo below. The interpretation of date code is week/year. The 4308 means the 43rd week of 2008.
